**Flood Control Project Maintenance
Levee Inspections**

Maintenance Issue Types Only, Levee Inspection Report By Mile - Spring 2018

Lake County Watershed Protection District

Waterway	Bank	Unit Miles	Inspection Start/End	Inspector
Unit No. 01 Middle Creek	Left	3.35	04/12/2018 04/12/2018	Bob Duffey

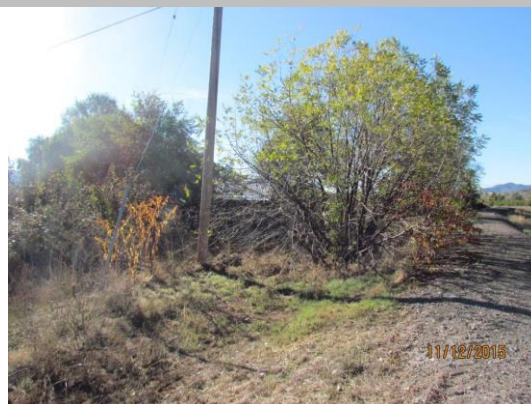
Photo 1 of 1 : SP_2018_NA0009_3_11_20180305_00006.jpg

LM Start	0.26	Rating **	M	Issue No.	11
LM End	0.26	Issue Type +	Ma	Location *	LS
Category	Earthen Levee		GPS Latitude/Longitude		
			Start	End	
Item	Trim / Thin Trees		39.186777 °	39.186777 °	
			-122.908102 °	-122.908102 °	
DWR ID	DWR_NA0009_01_s_2013_11				
Comment Code					
T3 : Trim and thin trees to allow visibility of the ground and room to flood fight.					
Inspector Comment

View of the overgrown trees at the landside slope.

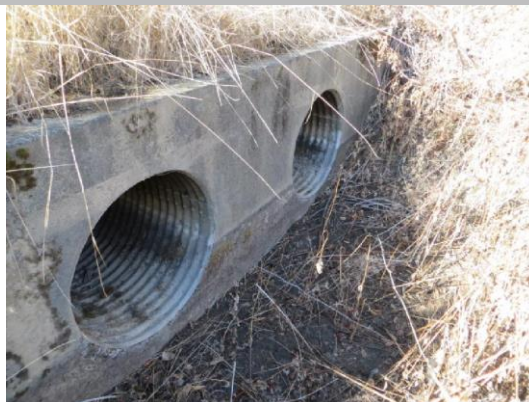
Photo 2 of 3 : UCIP_SP_2018_26987_49852.jpg

Pipe and Concrete headwall visible on LS toe.

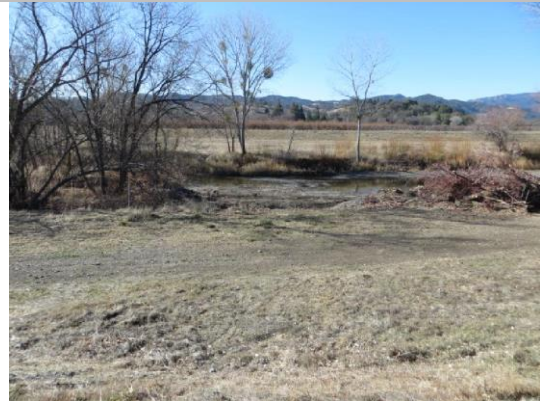
Photo 3 of 3 : UCIP_SP_2018_26987_49851.jpg

LM Start	2.26	Rating **	A/W	Issue No.	537 (cont)
LM End	2.26	Issue Type +	Ma	Location *	
Category	Supplemental			GPS Latitude/Longitude	
				Start	End
Item	DWR UCIP LMA Responsibility			39.160327 °	39.160327 °
				-122.913998 °	-122.913998 °
DWR ID					
Comment Code					
Inspector Comment					
FS_ID:26987 DS_ID:21240 EP_NO: N/A Repair Type: No Action Needed Crossing Status: Found UCIP Comments: FIELD_STRUCT_DESC: 2 of 2: 36-inch corrugated metal drainage pipe through the levee, 9 feet below the crown. Flap gate on the waterside (WS) end. Concrete headwalls on both ends. (two 36-inch pipes [HLM 2.26] retained under Automatic Board Order (ABO) issued as Permit No. 11460, 1975 - Robert L. and Lavona Gentry). [Additional Reference(s): DWR Levee Log, 2005. USACE Sacramento O&M Manual 506.2, August 1961, (HLM 2.26)]. FS Date: 1/14/2014

Pipe, Concrete headwall, and flap gate visible on WS berm.

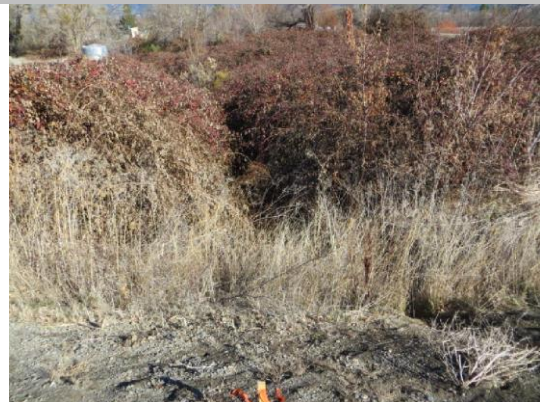
Photo 1 of 3 : UCIP_SP_2018_26986_49849.jpg

LM Start	2.26	Rating **	A/W	Issue No.	538
LM End	2.26	Issue Type +	Ma	Location *	
Category	Supplemental			GPS Latitude/Longitude	
				Start	End
Item	DWR UCIP LMA Responsibility			39.160272 °	39.160272 °
				-122.913966 °	-122.913966 °
DWR ID					
Comment Code					
Inspector Comment					
FS_ID:26986 DS_ID:21197 EP_NO: N/A Repair Type: No Action Needed Crossing Status: Found UCIP Comments: FIELD_STRUCT_DESC: 1 of 2: 36-inch corrugated metal drainage pipe through the levee, 9 feet below the crown. Flap gate on the waterside (WS) end. Concrete U-shaped headwalls on both ends. (two 36-inch pipes [HLM 2.26] retained under Automatic Board Order (ABO) issued as Permit No. 11460, 1975 - Robert L. and Lavona Gentry). [Additional Reference(s): DWR Levee Log, 2005. USACE Sacramento O&M Manual 506.2, August 1961, (HLM 2.26)]. FS Date: 1/9/2014

Concrete headwall and pipe visible on LS toe at end of drainage swale.

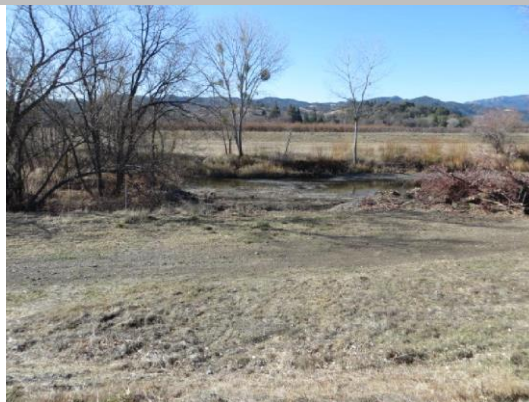
Photo 3 of 3 : UCIP_SP_2018_26986_49847.jpg

Concrete headwall and pipe visible on WS berm.

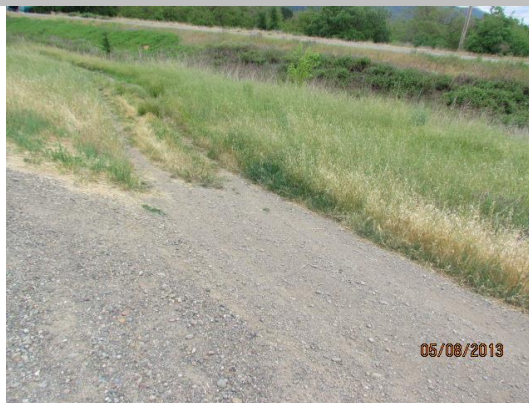
Photo 1 of 1 : SP_2018_NA0009_3_14_20180305_00008.jpg

LM Start	2.36	Rating **	M	Issue No.	14	
LM End	2.36	Issue Type +	Ma	Location *	WS	
Category	Earthen Levee			GPS Latitude/Longitude		
				Start		End
Item	Slope Stability			39.161153 °		39.161153 °
				-122.912740 °		-122.912740 °
DWR ID	DWR_NA0009_01_s_2013_14					
Comment Code						
S3 : Repair the levee slope damaged by vehicle traffic and prevent access where possible.						
Inspector Comment

View of the vehicle erosion along the waterside slope.

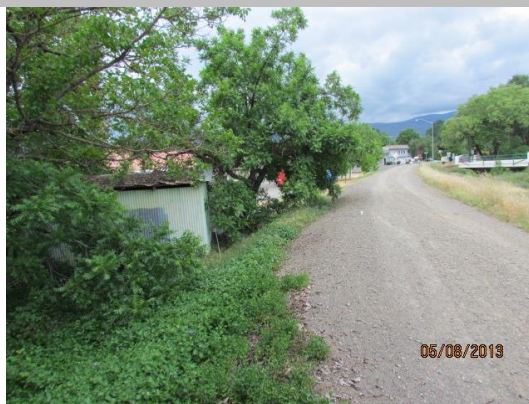
Photo 1 of 1 : SP_2018_NA0009_3_15_20180305_00009.jpg

LM Start	2.38	Rating **	M	Issue No.	15
LM End	2.41	Issue Type +	Ma	Location *	LS
Category	Earthen Levee			GPS Latitude/Longitude	
				Start	End
Item	Trim / Thin Trees			39.161381 °	39.161708 °
				-122.912551 °	-122.912168 °
DWR ID	DWR_NA0009_01_s_2013_15				
Comment Code					
T1 : Trim trees to at least five feet above ground level.					
Inspector Comment					
trim the trees to at least 5 feet above the ground for visibility and remove the vegetation from the slope.

Trim the trees up 5 feet to allow visibility.

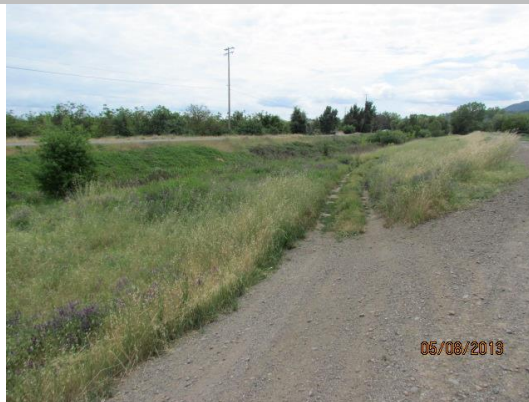
Photo 1 of 1 : SP_2018_NA0009_3_16_20180305_00010.jpg

LM Start	2.40	Rating **	M	Issue No.	16
LM End	2.40	Issue Type +	Ma	Location *	WS
Category	Earthen Levee			GPS Latitude/Longitude	
				Start	End
Item	Slope Stability			39.161601 °	39.161601 °
				-122.912303 °	-122.912303 °
DWR ID	DWR_NA0009_01_s_2013_16				
Comment Code					
S3 : Repair the levee slope damaged by vehicle traffic and prevent access where possible.					
Inspector Comment

View of the vehicle erosion along the waterside slope.

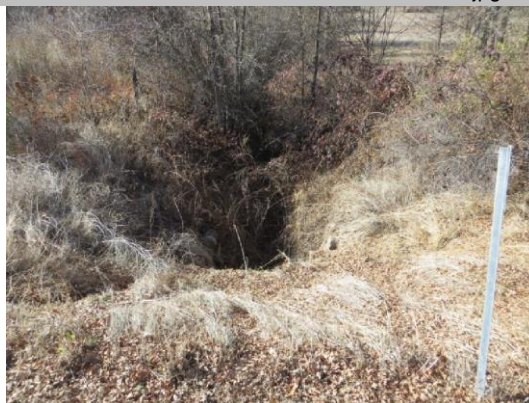
Photo 1 of 3 : UCIP_SP_2018_27066_50049.jpg

LM Start	0.14	Rating **	A/W	Issue No.	32
LM End	0.14	Issue Type +	Ma	Location *	
Category	Supplemental			GPS Latitude/Longitude	
				Start	End
Item	DWR UCIP LMA Responsibility			39.187919 °	39.187919 °
				-122.908631 °	-122.908631 °
DWR ID					
Comment Code					
Inspector Comment					
FS_ID:27066 DS_ID:21201 EP_NO: 11485 Repair Type: No Action Needed Crossing Status: Found UCIP Comments: FIELD_STRUCT_DESC: 42-inch corrugated metal drainage pipe through the levee, 8.5 feet below the crown. Flap gate on the waterside (WS). Concrete headwalls on both ends. (42-inch pipe [HLM 0.13] retained under Automatic Board Order (ABO) issued as Permit No. 11485, 1975 - John and Vivian Strickfaden). [Additional Reference(s): DWR Levee Log, 2005. USACE Sacramento O&M Manual 506.2, August 1961, (HLM 0.13)]. FS Date: 1/14/2014

Pipe and headwall visible at LS toe in drainage swale.

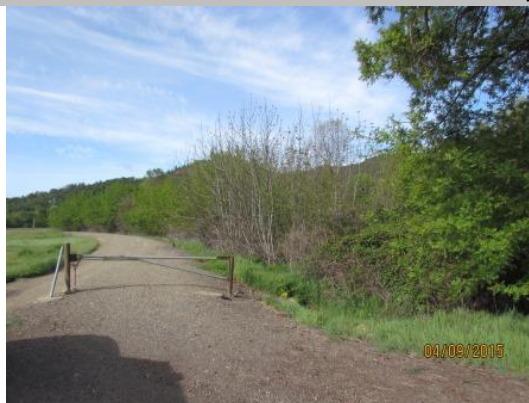
Photo 1 of 1 : SP_2018_NA0009_4_9_20180305_00006.jpg

View of the overgrown trees and vegetation at the landside toe.

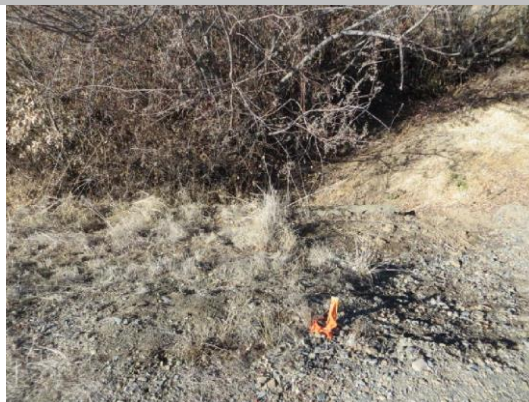
Photo 1 of 3 : UCIP_SP_2018_27192_50326.jpg

LM Start	0.39	Rating **	A/W	Issue No.	34
LM End	0.39	Issue Type +	Ma	Location *	
Category	Supplemental			GPS Latitude/Longitude	
				Start	End
Item	DWR UCIP LMA Responsibility			39.185174 °	39.185174 °
				-122.911171 °	-122.911171 °
DWR ID					
Comment Code					
Inspector Comment					
FS_ID:27192 DS_ID:21206 EP_NO: 11478 Repair Type: No Action Needed Crossing Status: Found UCIP Comments: FIELD_STRUCT_DESC: 42-inch corrugated metal drainage pipe through the levee, 7.7 feet below the crown. Flap gate on the waterside (WS) end. Concrete headwalls on both ends. Grouted spillway over revetment on bank. (42-inch pipe [HLM 0.38] retained under Automatic Board Order (ABO) issued as Permit No. 11478, 1975 - William D. and Dorothy L. Allison). [Additional Reference(s): DWR Levee Log, 2005. USACE Sacramento O&M Manual 506.2, August 1961, (HLM 0.38)]. FS Date: 1/14/2014

Pipe and concrete headwall at LS toe.

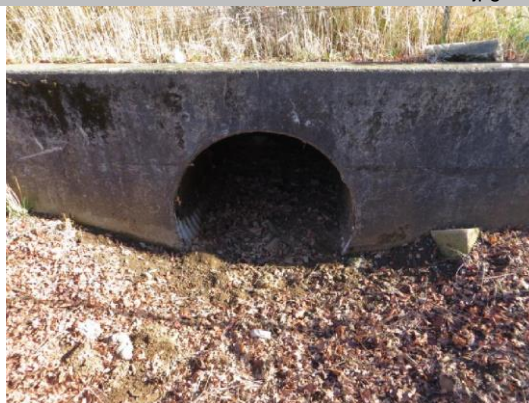
Photo 1 of 3 : UCIP_SP_2018_27199_50389.jpg

LM Start	0.48	Rating **	A/W	Issue No.	35
LM End	0.48	Issue Type +	Ma	Location *	
Category	Supplemental			GPS Latitude/Longitude	
				Start	End
Item	DWR UCIP LMA Responsibility			39.184126 °	39.184126 °
				-122.912118 °	-122.912118 °
DWR ID					
Comment Code					
Inspector Comment					
FS_ID:27199 DS_ID:21208 EP_NO: 11480 Repair Type: No Action Needed Crossing Status: Found UCIP Comments: FIELD_STRUCT_DESC: 42-inch corrugated metal drainage pipe through the levee, 7 feet below the crown. Flap gate on the waterside (WS) end. Concrete headwalls on both ends. (42-inch pipe [HLM 0.47] retained under Automatic Board Order (ABO) issued as Permit No. 11480, 1975 - Jose G. and Dora Moto). [Additional Reference(s): DWR Levee Log, 2005. USACE Sacramento O&M Manual 506.2, August 1961, (HLM 0.47)]. FS Date: 1/14/2014

Concrete headwall on LS toe.

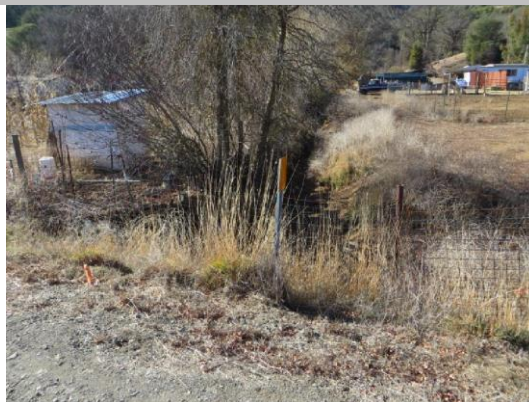
Photo 2 of 3 : UCIP_SP_2018_27199_50388.jpg

Pipe and concrete headwall on LS toe.

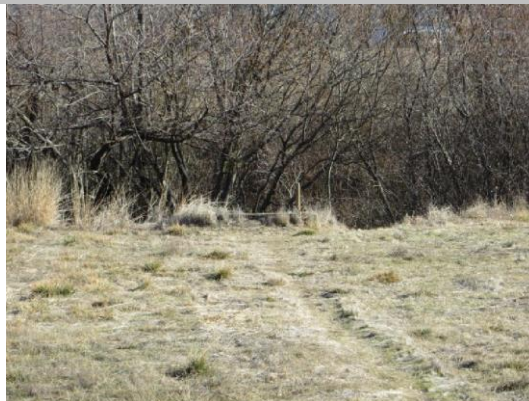
Photo 3 of 3 : UCIP_SP_2018_27199_50387.jpg

LM Start	0.48	Rating **	A/W	Issue No.	35 (cont)	
LM End	0.48	Issue Type +	Ma	Location *		
Category	Supplemental			GPS Latitude/Longitude		
				Start	End	
Item	DWR UCIP LMA Responsibility			39.184126 °	39.184126 °	
				-122.912118 °	-122.912118 °	
DWR ID						
Comment Code						
Inspector Comment						
FS_ID:27199 DS_ID:21208 EP_NO: 11480 Repair Type: No Action Needed Crossing Status: Found UCIP Comments: FIELD_STRUCT_DESC: 42-inch corrugated metal drainage pipe through the levee, 7 feet below the crown. Flap gate on the waterside (WS) end. Concrete headwalls on both ends. (42-inch pipe [HLM 0.47] retained under Automatic Board Order (ABO) issued as Permit No. 11480, 1975 - Jose G. and Dora Moto). [Additional Reference(s): DWR Levee Log, 2005. USACE Sacramento O&M Manual 506.2, August 1961, (HLM 0.47)]. FS Date: 1/14/2014

Concrete headwall and flapgate visible on waterside berm

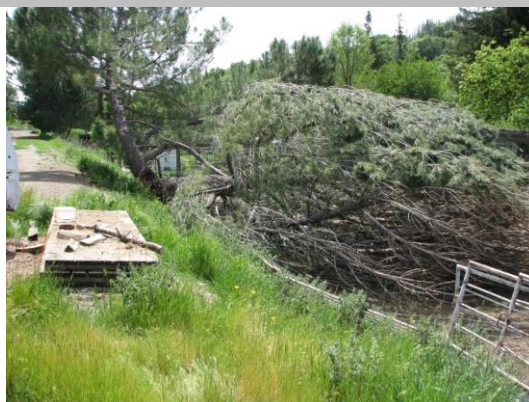
Photo 1 of 1 : SP_2018_NA0009_4_20_20180305_00011.jpg

LM Start	0.49	Rating **	M	Issue No.	20
LM End	0.51	Issue Type +	Ma	Location *	LS
Category	Earthen Levee			GPS Latitude/Longitude	
				Start	End
Item	Trim / Thin Trees			39.184001 °	39.183676 °
				-122.912139 °	-122.912179 °
DWR ID	DWR_NA0009_02_s_2016_20				
Comment Code					
T2 : Thin trees to allow visibility of the ground and room to flood fight.					
Inspector Comment					
Remove large downed pine tree branch on LS toe.

View of the fallen tree branch on landside slope and toe.

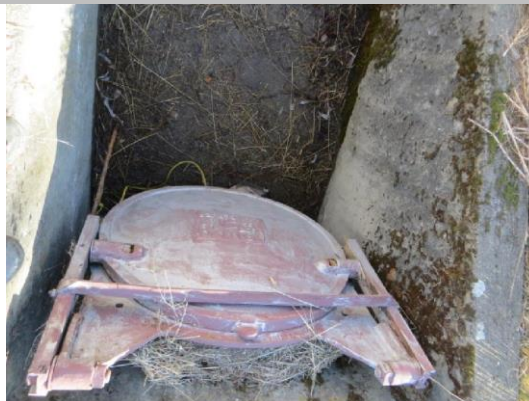
Photo 3 of 3 : UCIP_SP_2018_27208_50409.jpg

LM Start	0.55	Rating **	M	Issue No.	38 (cont)	
LM End	0.55	Issue Type +	Ma	Location *		
Category	Supplemental			GPS Latitude/Longitude		
				Start	End	
Item	DWR UCIP LMA Responsibility			39.183130 °	39.183130 °	
				-122.912198 °	-122.912198 °	
DWR ID						
Comment Code						
Inspector Comment						
FS_ID:27208 DS_ID:21210 EP_NO: 11482 Repair Type: Non-Urgent Crossing Status: Found UCIP Comments: Fence on LS slope creates access issue. FIELD_STRUCT_DESC: 36-inch corrugated metal drainage pipe through the levee, 9 feet below the crown. Flap gate on the waterside (WS) end. Concrete headwalls on both ends. (36-inch pipe [HLM 0.54] retained under ABO No. 11482, 1975 - George R. and Gladys Schneider). [Additional Reference(s): DWR Levee Log, 2005. USACE Sacramento O&M Manual 506.2, August 1961, (HLM 0.54)]. FS Date: 1/14/2014

Flapgate and concrete headwall on WS berm.

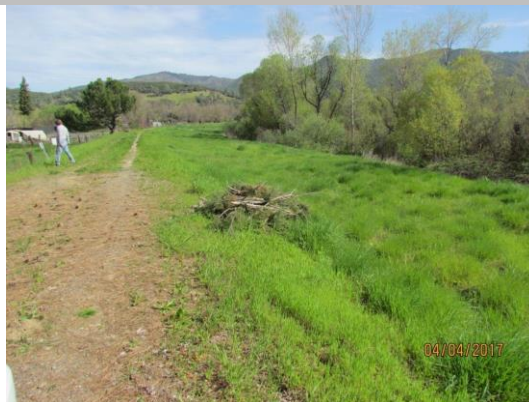
Photo 1 of 1 : SP_2018_NA0009_4_30_20180305_00013.jpg

LM Start	0.56	Rating **	M	Issue No.	30
LM End	0.56	Issue Type +	Ma	Location *	WS
Category	Earthen Levee			GPS Latitude/Longitude	
				Start	End
Item	Encroachments			39.182940 °	39.182940 °
				-122.912142 °	-122.912142 °
DWR ID	DWR_NA0009_02_s_2017_30				
Comment Code					
PR : Prunings					
Inspector Comment					
Remove the prunings from the waterside slope.

View of the prunings along the waterside slope.

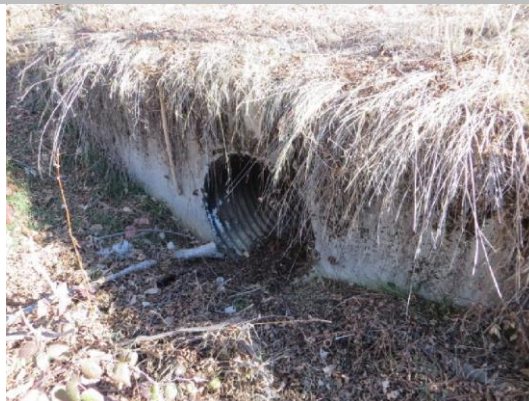
Photo 1 of 3 : UCIP_SP_2018_27583_51202.jpg

LM Start	1.03	Rating **	A/W	Issue No.	39
LM End	1.03	Issue Type +	Ma	Location *	
Category	Supplemental			GPS Latitude/Longitude	
				Start	End
Item	DWR UCIP LMA Responsibility			39.176366 °	39.176366 °
				-122.913509 °	-122.913509 °
DWR ID					
Comment Code					
Inspector Comment					
FS_ID:27583 DS_ID:21211 EP_NO: 11486 Repair Type: No Action Needed Crossing Status: Found UCIP Comments: FIELD_STRUCT_DESC: 36-inch corrugated metal drainage pipe through the levee, 7.3 feet below the crown. Flap gate on the waterside (WS) end. Concrete headwalls on both ends. Splash apron broken off on the WS end. (36-inch pipe [HLM 1.08] retained under Automatic Board Order (ABO) issued as Permit No. 11486, 1975 - Mary Truesdell). [Additional Reference(s): DWR Levee Log, 2005. USACE Sacramento O&M Manual 506.2, August 1961, (HLM 1.08) Drawing No. CC-4-4-29]. FS Date: 1/22/2014

Pipe visible at concrete inlet on LS toe.

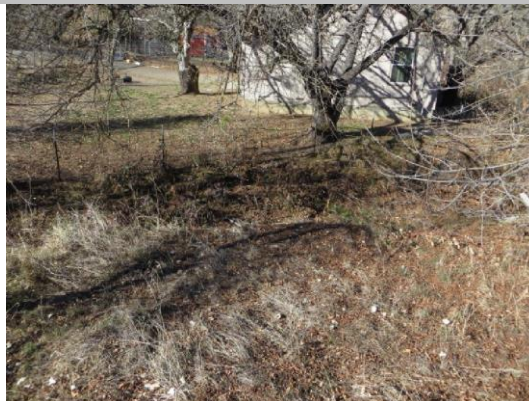
Photo 3 of 3 : UCIP_SP_2018_27583_51200.jpg

LM Start	1.03	Rating **	A/W	Issue No.	39 (cont)	
LM End	1.03	Issue Type +	Ma	Location *		
Category	Supplemental			GPS Latitude/Longitude		
				Start	End	
Item	DWR UCIP LMA Responsibility			39.176366 °	39.176366 °	
				-122.913509 °	-122.913509 °	
DWR ID						
Comment Code						
Inspector Comment						
FS_ID:27583 DS_ID:21211 EP_NO: 11486 Repair Type: No Action Needed Crossing Status: Found UCIP Comments: FIELD_STRUCT_DESC: 36-inch corrugated metal drainage pipe through the levee, 7.3 feet below the crown. Flap gate on the waterside (WS) end. Concrete headwalls on both ends. Splash apron broken off on the WS end. (36-inch pipe [HLM 1.08] retained under Automatic Board Order (ABO) issued as Permit No. 11486, 1975 - Mary Truesdell). [Additional Reference(s): DWR Levee Log, 2005. USACE Sacramento O&M Manual 506.2, August 1961, (HLM 1.08) Drawing No. CC-4-4-29]. FS Date: 1/22/2014

Pipe visible on LS toe.

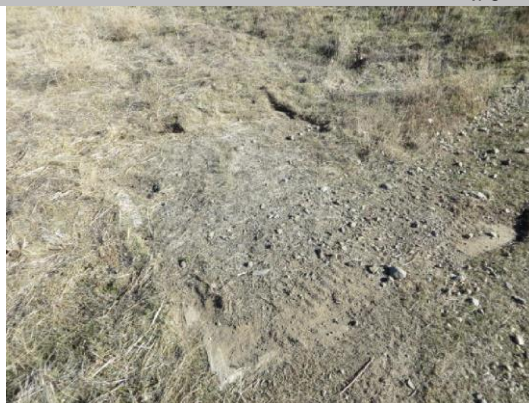
Photo 2 of 3 : UCIP_SP_2018_42994_51213.jpg

FS_ID:42994
DS_ID:21212
EP_NO: 11483
Repair Type: Non-Urgent
Crossing Status: Found
UCIP Comments: Pipe appears abandoned and if so, should be done so properly. Debris blocking flapgate at outlet.
FIELD_STRUCT_DESC: *ABANDONED* 30-inch corrugated metal drainage pipe through the levee, 17.8 feet below the crown. Slide gate in 44-inch corrugated metal riser unit on the waterside (WS) slope. Flap gate on the WS end at concrete headwall. 6-foot by 8-foot concrete sump at the landside (LS) toe. (30-inch pipe [HLM 1.22] retained under Automatic Board Order (ABO) issued as Permit No. 11483, 1975 - Edward M. and Mildred E. Seely). [Additional Reference(s): DWR Levee Log, 2005. USACE Sacramento O&M Manual 506.2, August 1961, (HLM 1.22)].
FS Date: 1/22/2014

6'X8' concrete sump filled in with soil, visible at LS toe.

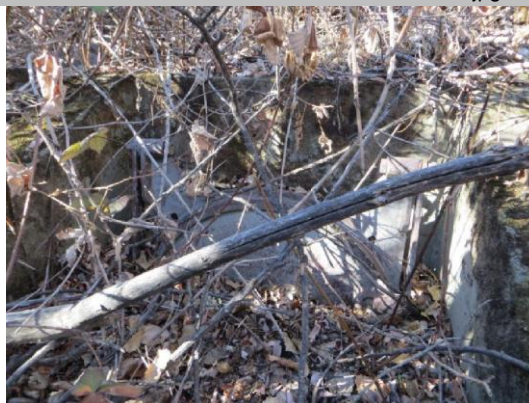
Photo 3 of 3 : UCIP_SP_2018_42994_51215.jpg

Comment Code						
Inspector Comment						
FS_ID:42994						
DS_ID:21212						
EP_NO: 11483						
Repair Type: Non-Urgent						
Crossing Status: Found						
UCIP Comments: Pipe appears abandoned and if so, should be done so properly. Debris blocking flapgate at outlet.						
FIELD_STRUCT_DESC: *ABANDONED* 30-inch corrugated metal drainage pipe through the levee, 17.8 feet below the crown. Slide gate in 44-inch corrugated metal riser unit on the waterside (WS) slope. Flap gate on the WS end at concrete headwall. 6-foot by 8-foot concrete sump at the landside (LS) toe. (30-inch pipe [HLM 1.22] retained under Automatic Board Order (ABO) issued as Permit No. 11483, 1975 - Edward M. and Mildred E. Seely). [Additional Reference(s): DWR Levee Log, 2005. USACE Sacramento O&M Manual 506.2, August 1961, (HLM 1.22)].						
FS Date: 1/22/2014

Flapgate and concrete headwall visible off WS berm.

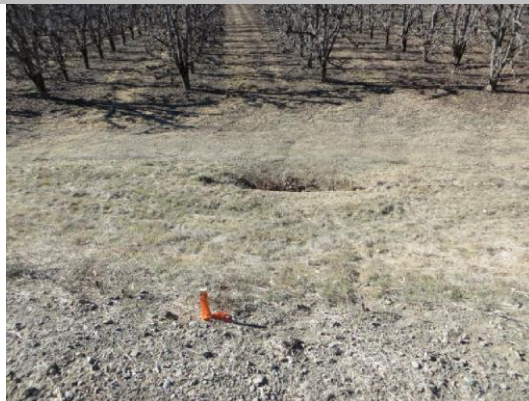
Photo 1 of 3 : UCIP_SP_2018_27630_51283.jpg

LM Start	2.84	Rating **	M	Issue No.	45
LM End	2.84	Issue Type +	Ma	Location *	
Category	Supplemental			GPS Latitude/Longitude	
				Start	End
Item	DWR UCIP LMA Responsibility			39.151257 °	39.151257 °
				-122.914908 °	-122.914908 °
DWR ID					
Comment Code					
Inspector Comment					
FS_ID:27630 DS_ID:21215 EP_NO: 11481 Repair Type: Non-Urgent Crossing Status: Found UCIP Comments: Soil partially blocking inlet and outlet. FIELD_STRUCT_DESC: 24-inch corrugated metal drainage pipe through the levee, 12 feet below the crown. Flap gate on the waterside (WS) end. Concrete headwalls on both ends. (24-inch pipe [HLM 2.93] retained under Automatic Board Order (ABO) issued as Permit No. 11481, 1975 - Dennis P. McCarthy). [Additional Reference(s): DWR Levee Log, 2005. USACE Sacramento O&M Manual 506.2, August 1961, (HLM 2.93)]. FS Date: 1/22/2014

Concrete headwall and pipe visible at LS toe.

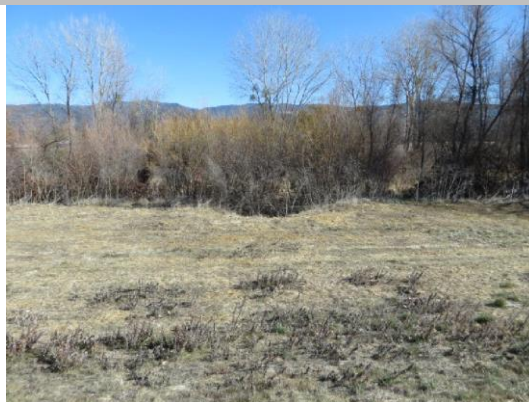
Photo 2 of 3 : UCIP_SP_2018_27630_51282.jpg

Concrete headwall and flapgate visible at WS berm.

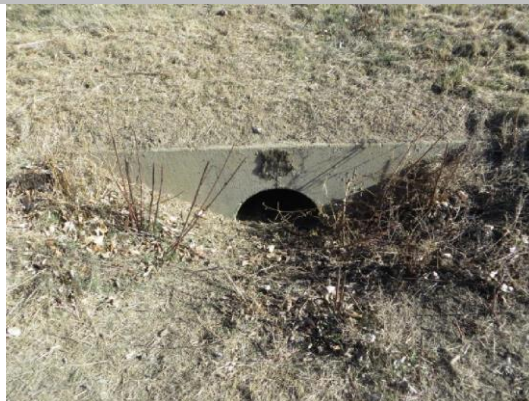
Photo 3 of 3 : UCIP_SP_2018_27630_51281.jpg

Concrete headwall and pipe visible at LS toe.

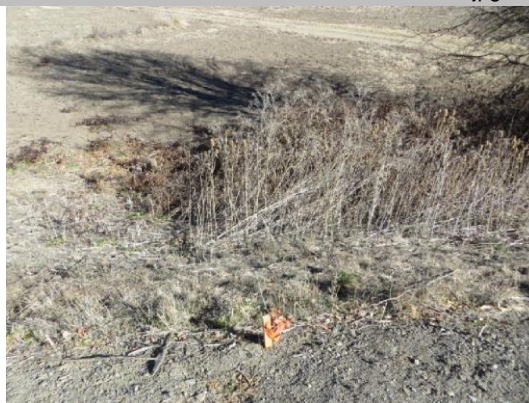
Photo 1 of 3 : UCIP_SP_2018_27863_51542.jpg

Pipe visible at LS toe covered with vegetation.

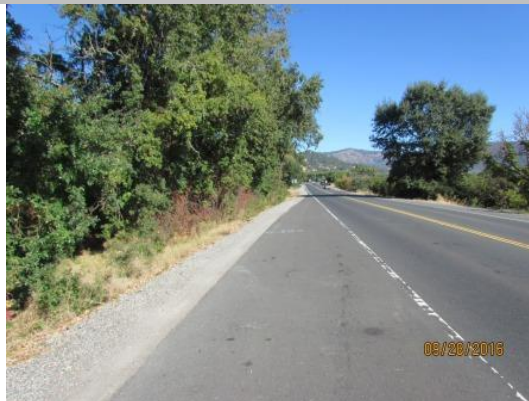
Photo 1 of 1 : SP_2018_NA0009_5_14_20180305_00005.jpg

View of the waterside vegetation looking upstream.

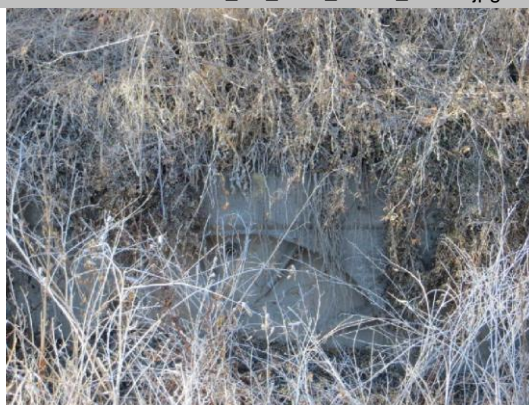
Photo 3 of 3 : UCIP_SP_2018_27893_51596.jpg

Concrete headwall and plugged pipe visible onLS toe of roadway.

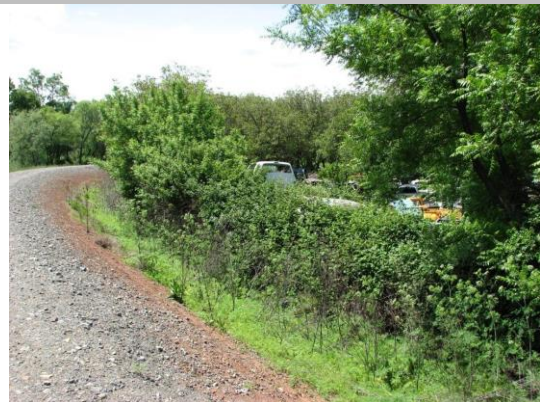
Photo 1 of 1 : SP_2018_NA0009_5_12_20180305_00003.jpg

5/2/2016: Dense bushes and vines covering fence along vehicle junk yard.

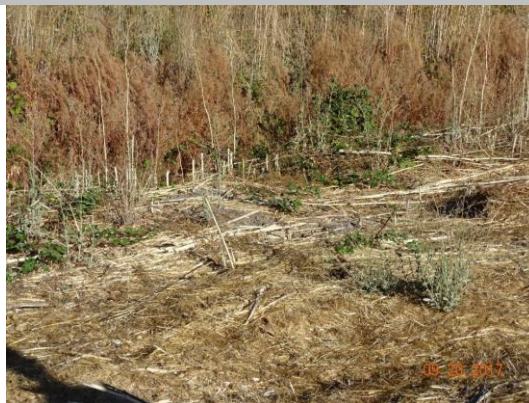
Photo 1 of 1 : SP_2018_NA0009_6_12_20180305_00005.jpg

View of the rodent holes along the landside slope & toe.

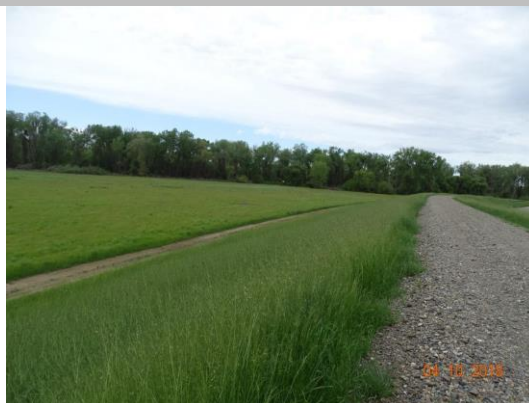
Photo 1 of 1 : SP_2018_NA0009_7_12_20180416_00028.jpg

View of native vegetation on landside slopes.
